Dhimish, M. and Kettle, J. (2021) Impact of solar cell cracks caused during potential-induced degradation (PID) tests. IEEE Transactions on Electron Devices, (doi: 10.1109/TED.2021.3135365).

# Impact of Solar Cell Cracks Caused During Potential Induced Degradation (PID) Tests

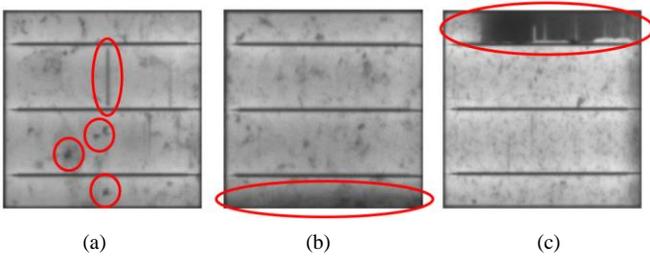
In Fig. 2, the EL image of solar cells affected by the typical cracks and/or structural defects is presented. These have been categorized into 3 groups by these authors; in Fig. 2(a), the cell is affected by minor cracks, whereas Fig. 2(b) shows that the cell has a dark area on the bottom edge. The last image, Fig. 2(c), presents a solar cell affected by a breakdown area.

Fig. 2. PV module affected by cracks or structural defect. (a) Minor cracks, (b) Dark area, (c) Breakdown the area.

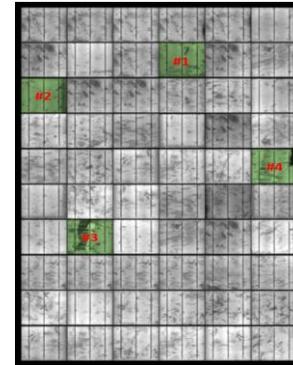
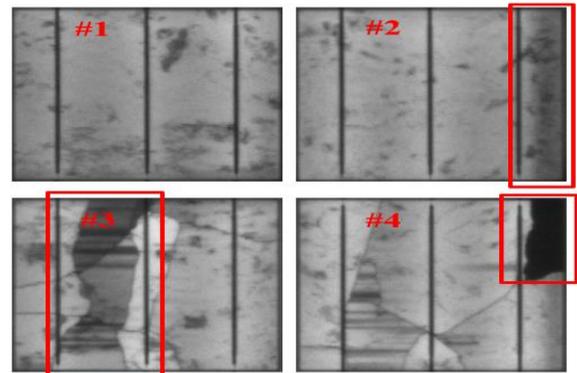
The last solar cell sample (#4) is affected by a breakdown region (labelled by the triangle). There are some proposals in the literature on whether this area can lead to PID or breakdown in the busbar; however, experimentation results have not yet been proclaimed. Hence, our results on examining these defects in the solar cells would significantly contribute to understanding the variations of the cracks along with their relationship with solar cell PID.

Fig. 4. (a) EL image of the PV module before the dismantling process, (b) After the dismantling process, the EL image of the tested solar cell samples, the first sample (#1), has a minor defect/crack across the cell. In contrast, samples (#2 and #3) are affected by a dark area with additional cracks in the cell. The last sample (#4) is affected by a breakdown region, as evidence by the solid black area.

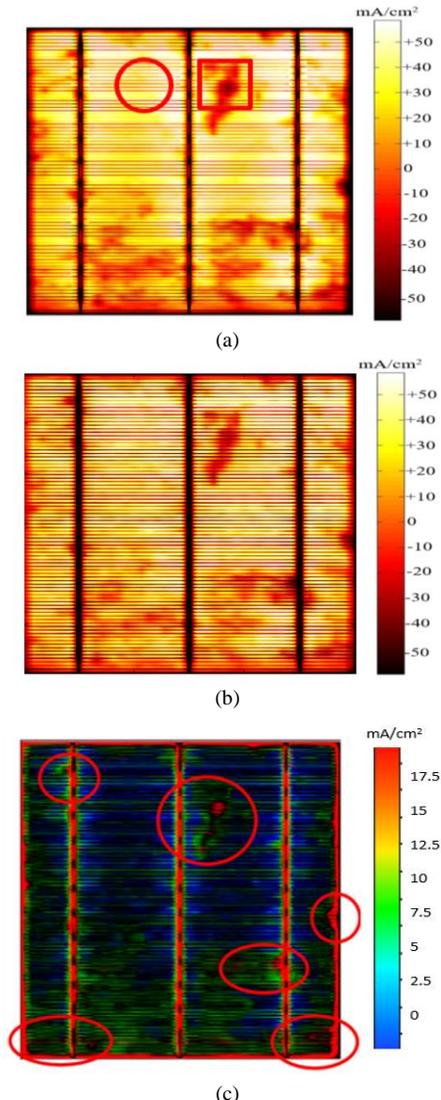
The image of the  $J_{sc}$  before and after the PID test is shown in Fig. 6(a) and Fig. 6(b), respectively. The difference between the before/after images is shown in Fig. 6(c). The most significant defects/cracks in the solar cell sees the biggest drop in  $J_{sc}$ . For example, on, the area labelled by the circle has no losses in the  $J_{sc}$ , 38 mA/cm<sup>2</sup>. However, for the cracked/fractured area, labelled by the rectangle, the  $J_{sc}$  drop is approximately equal to -10 mA/cm<sup>2</sup> (27% relative reduction). This would correspond to a hotspot in an operational PV module, potentially leading to greater module defects as time progressed.

Following the observation of sample #1, minor cracked/defective areas in a solar cell are unlikely to cause a major and immediate PID. This consequence was concluded by observing that the pattern of Fig. 6(a) and Fig. 6(b) are almost equal. There are moderate differences between the  $J_{sc}$  before and after the PID, as shown in Fig. 6(c). We have labelled the key areas that exhibit a reduction in (leakage) current after the PID testing was completed. The blue regions in Fig. 6(c) correspond to a negligible change in degradation (no difference in the  $J_{sc}$ ).

Fig. 6.  $J_{sc}$  for Solar cell #1. (a) before the PID test, (b) after the PID is completed, (c) Difference in the  $J_{sc}$  before and after the PID test.

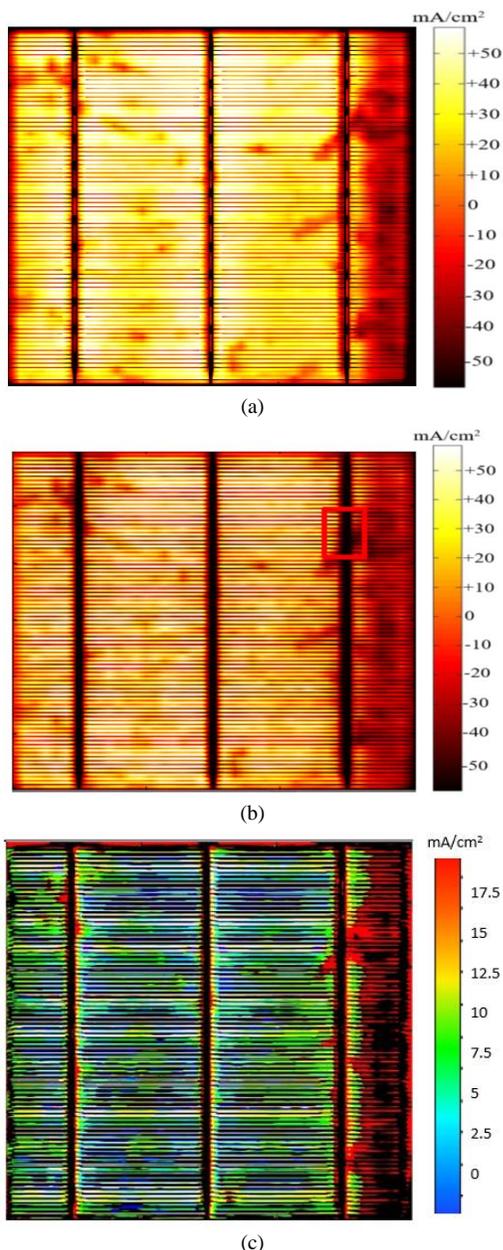
Now consider the behavior of solar cell sample #2, where the LBIC images before the PID test began is shown in Fig. 7(a). The dark area on the right-hand side of the solar cell clearly exhibits a drop in the  $J_{sc}$ . In agreement with the earlier data, the  $J_{sc}$  reduced significantly after the PID test was completed (Fig. 7(b)). Remarkably, the images indicate that the dark area is likely to be causing a more severe PID to the cell. There is a noticeable expansion of the dark regions across the right-hand side where the original EL image has an initial dark area.

The difference between the  $J_{sc}$  before and after the PID test is shown in Fig. 7(c). There is a significant drop in the current on the right-hand side of the solar cell, which is the same area that had the initial shading/defect. This confirms that such dark areas in the original EL images can be classified as high-risk regions for PID degradation in solar cells.

Fig. 7.  $J_{sc}$  for Solar cell #2. (a) before the PID test, (b) after the PID is completed, (c) Difference in the  $J_{sc}$  before and after the PID test.

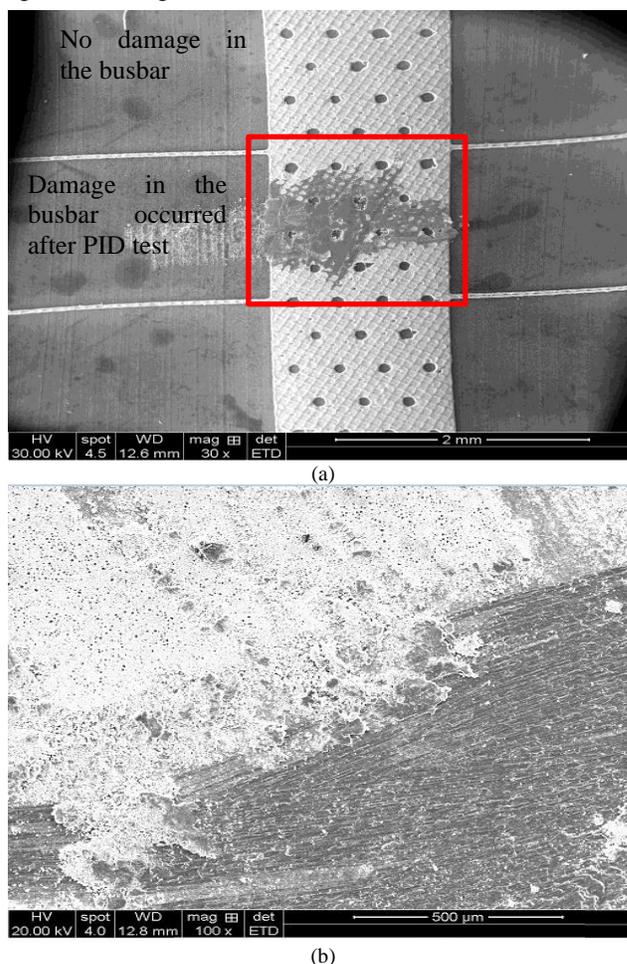
We have taken the SEM image of the labelled area in Fig 7(b) for further examination. The output image of the inspection is shown in Fig. 8(a). We have witnessed that after performing the PID test, the dark area (potential crack) damaged the busbar, this is evident by the front surface view.

In Fig. 8(b), we have observed at the back surface of the busbar. The PID test initiated further damage to the rear surface of the solar cell sample. There are a number of ‘pits’ in the contacts and material migration from the contact areas. As a result, we prove that it is likely to have a critical PID for a solar cell that comprises entirely/partially dark regions in the original EL image.

Fig. 8. SEM for solar cell #2. (a) front surface, (b) Back surface.

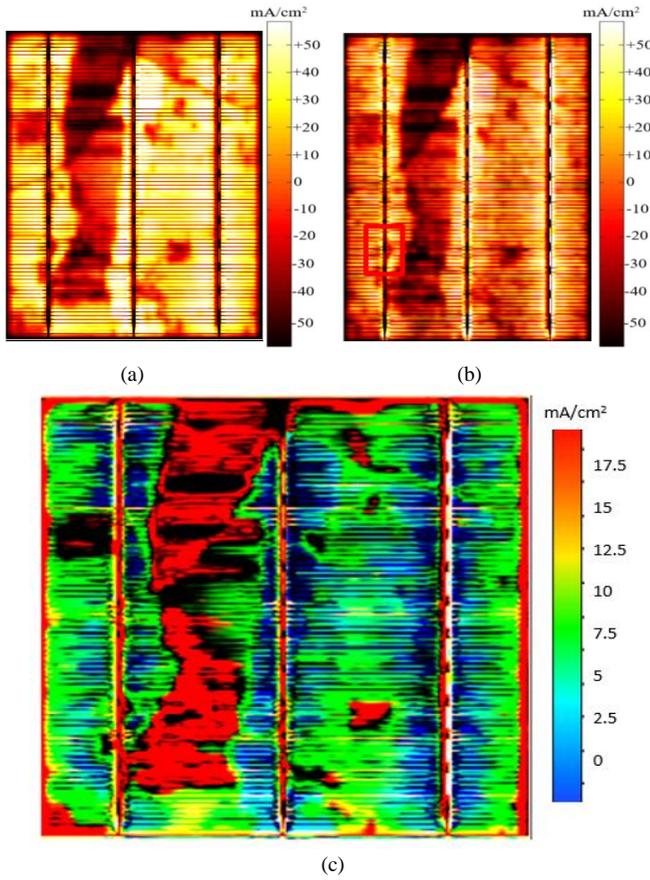
Now, considering solar cell sample #3 which was also imaged before and after PID testing. The  $J_{sc}$  before the PID test is shown in Fig. 9(a), whilst after the PID test is performed, a large reduction in the  $J_{sc}$  was observed, particularly in the dark area on the left-hand side of the EL image, and in the LBIC image, which is shown in Fig. 9(b).

The difference between the  $J_{sc}$  before and after the PID test is shown in Fig. 9(c). We can remark that there is negative current (leakage) in the areas where the dark (crack) is present. This result reinforces our earlier conclusion that cracks can lead to greater decreases in current density, indicative of regions where the solar cell operation has completely broken down. Hence, hotspots are expected to appear these locations if the cell is operated under field conditions, which would lead to further degradation.

Fig. 9.  $J_{sc}$  for Solar cell #3. (a) before the PID test, (b) after the PID is completed, (c) Difference in the  $J_{sc}$  before and after the PID test.

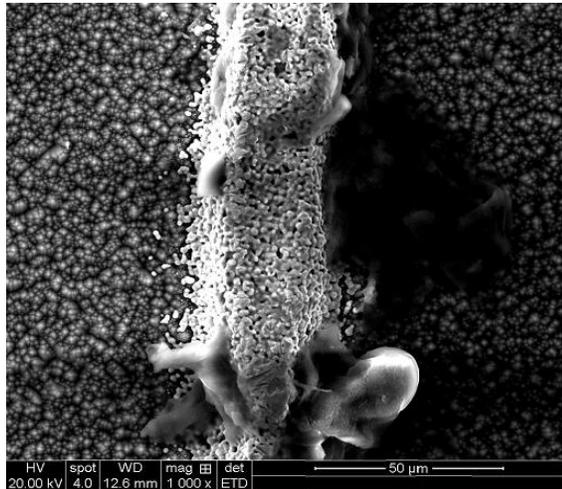
In contrast, we have further investigated the labelled area in Fig. 9(b), using an SEM. The result of the SEM inspection is displayed in Fig. 10. By inspection of the busbar's metallic (solder) joint to the solar cell surface, it is evident that the solder has migrated and deformed around the solder joint. This microscopic observation leads to understand why some solar cells, after PID tests, demonstrate significant decreases in the output current; clearly these changes lead to the development of hotspots and open circuits forming at the solder joints.

Fig. 10. SEM image for the front surface of the labelled area in Fig. 9(b).

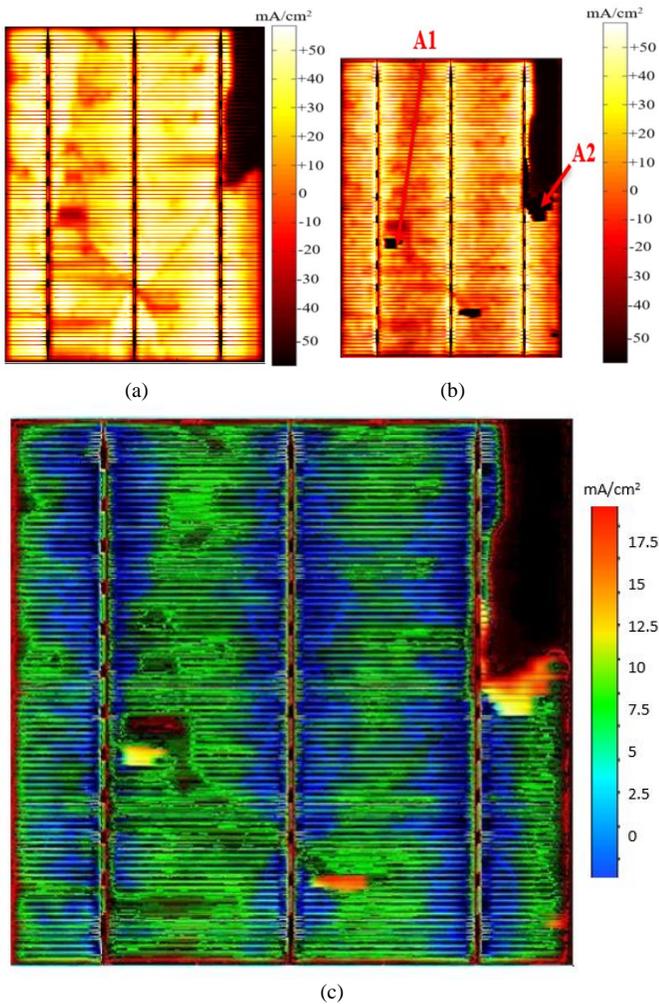
In In Fig. 12(a), we show the results of the  $J_{sc}$  for the last solar cell sample #4, which exhibited the largest number of cracks at the outset. We can notice in the initial EL image that the black area represents a complete breakdown in the cell. After the PID test was completed, the image (Fig. 12(b)) confirms an expansion of the breakdown area in the cell (labelled as A1 and A2). In Fig. 12(c), the difference in the  $J_{sc}$  before and after the PID test is presented. The expansion in the defect is evident indicating complete breakdown of  $\sim 15\%$  of the cell. The cause of this breakdown is likely to be due to localized heating of the silicon material leading to expansion and greater stress on the cracked surface. It is worth noting that, if the solar cell sample were still exposed in the field, these additional breakdown regions would appear after a longer period, for example after months of operation, due to the lower stress conditions.

Fig. 12.  $J_{sc}$  for Solar cell #4. (a) before the PID test, (b) after the PID test, (c) Difference in the  $J_{sc}$  before and after the PID test.

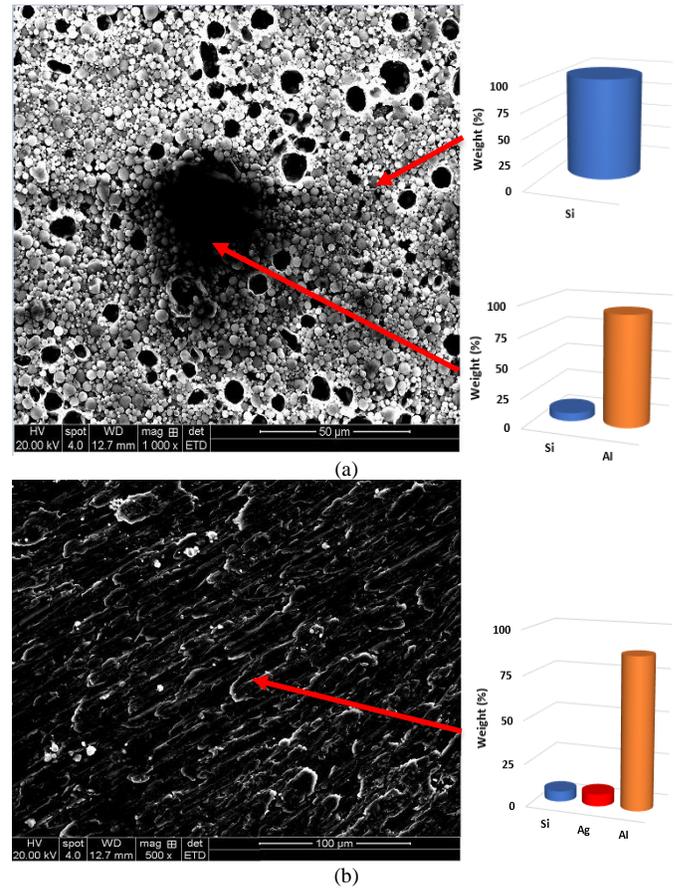
The breakdown areas were analyzed using a SEM. For example, the output SEM image for A1 is shown in Fig. 13(a). It appears that the crack has initiated a significant breakdown in the cell (the black area in the middle of Fig. 13(a)) and hundreds of similar potential breakdown blocks in the surrounding area. The white areas in the image represent as Silicon using Energy-dispersive X-ray spectroscopy (EDX). In comparison, the black area corresponds to aluminum (Al), indicating that a large defect in the solar cell, and the solar cell rear contact (made of Al) is only visible. Additionally, the SEM image for A2 is shown in Fig. 13(b); only 6% silicon was found in this area, along with 7% silver (Ag) due to the expansion of the busbar material and 87% of Al. Accordingly, this part of the solar cell has a complete breakdown, not generating any photocurrent.

In reviewing the abovementioned observations, the breakdown area in the solar cell sample #4 leads to a drop in the  $J_{sc}$  after the PID test was completed and a further breakdown area adjacent to the initial breakdown. These observations suggest the following:

Fig. 13. (a) SEM image for the front surface of area A1, (b) SEM image for the front surface of area A2.

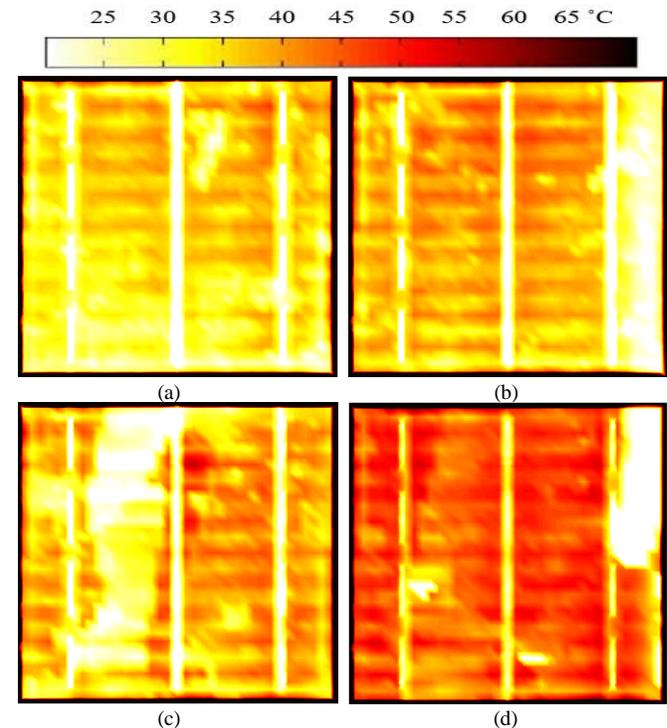
The results of the experiment are presented in Fig. 15. We can remark that the cell's temperature of cell #1 is uniformly distributed and at nearly STC condition, 25 degrees. For cell #2 and cell #3, it is evident that there is a localized increase in the temperature, which reaches as high as  $40^\circ C$  in the areas where a crack (dark) appears. Considering Fig. 15(c), we can recognise that in the middle busbar, there is a minor hotspot is now affecting the cell; this is because of the expansion of the crack after the PID was performed.

Because cell #4 has the large breakdown region (as shown in the earlier EL image in Fig. 4), a rapid increase ( $60^\circ C$ ) of the cell temperature is observed. This is because a reverse-biased voltage is expected in this region, hence, a hotspot in the cell has now been developed. In summary, the main effects of the cracks themselves on hotspot temperatures are,

Fig. 15. Thermal image of the solar cell samples ( $125 \times 125$  mm) at 1000  $W/m^2$ . (a) Solar cell #1, (b) Solar cell #2, (c) Solar cell #3, (d) Solar cell #4.
