Dhimish, M. and Kettle, J. (2021) Impact of solar cell cracks caused during potential-induced degradation (PID) tests. IEEE Transactions on Electron Devices, (doi: 10.1109/TED.2021.3135365).

# Impact of Solar Cell Cracks Caused During Potential Induced Degradation (PID) Tests

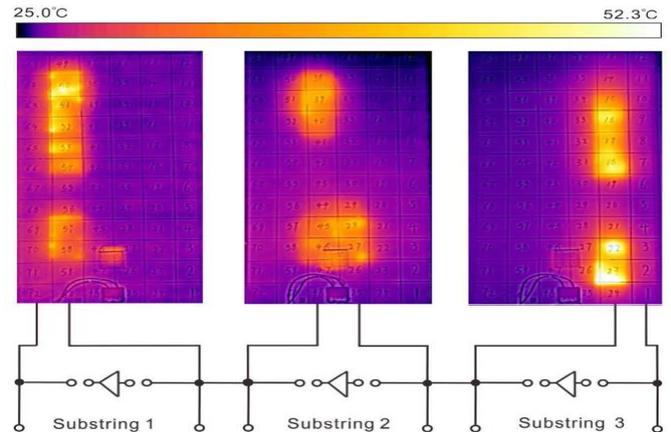
In a recent study, [6], a PV module subjected to a reverse bias of 160 V voltage was shown to exhibit severe PID, leading to the formation of hotspots which appeared on the

Fig. 1. Thermographic image of three substrings of module 3 under reverse 160 V bias [6].

modules, as presented in Fig. 1 for three different PV modules connected in series. This study showed that the PID resulted in a reduction of the current density and the open-circuit voltage. Improved testing has been the focus of much recent research; for example, in [7], authors have presented an approach to test the reversible and irreversible PID testing to bifacial PERC solar cells. Other researchers [8, 9] have reported that cracks in solar cells can accelerate PID due to the localized heat caused by the cracks. This work was supported by studies conducted using electroluminescence (EL) imaging before and after PID testing. This affirmed that cracks could lead to hotspots in the solar cells, and as a result, PID is expected, yet there were no discussions on the type/size of cracks and their expected impact upon PID.

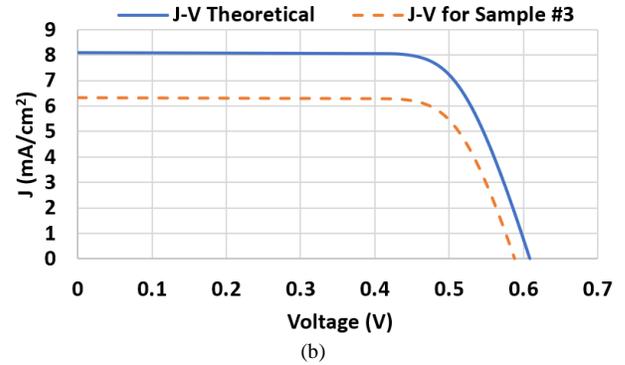
As the solar cell exhibits significant losses in the  $J_{sc}$  we have decided to test the cell under standard test conditions (illumination of  $1000 \text{ W/m}^2$  and cell temperature 25 degrees), as shown in Fig. 11(a). The resultant current-voltage (J-V) curve compared with the theoretical values (taken from the solar cell datasheet) is shown in Fig. 11(b). The current density at short circuit conditions dropped by 20.5%, calculated using (1), whereas 4.9% was the drop in the  $V_{oc}$  calculated using (2). This concludes the fact that dark areas in EL images likely means that the cells are being impacted with severe PID.

$$\text{Drop in } J_{sc} = \frac{\text{Theoretical } J_{sc} - \text{Measured } J_{sc}}{\text{Theoretical } J_{sc}} \times 100 = \frac{38.1 - 30.3}{38.1} \times 100 = 20.5\% \quad (1)$$

$$\text{Drop in } V_{oc} = \frac{\text{Theoretical } V_{oc} - \text{Measured } V_{oc}}{\text{Theoretical } V_{oc}} \times 100 = \frac{0.61 - 0.58}{0.61} \times 100 = 4.9\% \quad (2)$$

Fig. 11. (a) The solar cell is exposed to  $1000 \text{ W/m}^2$  illumination, (b) Measured J-V curve under STC conditions.

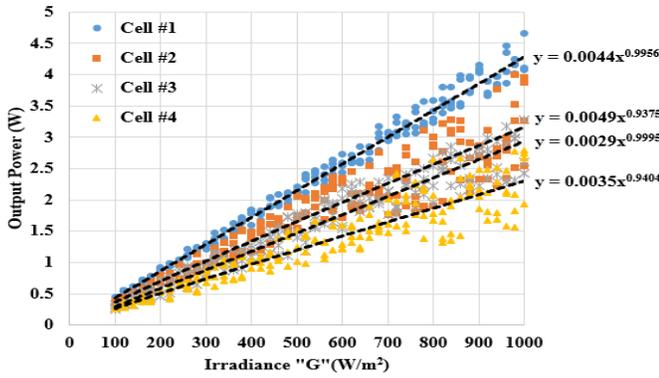
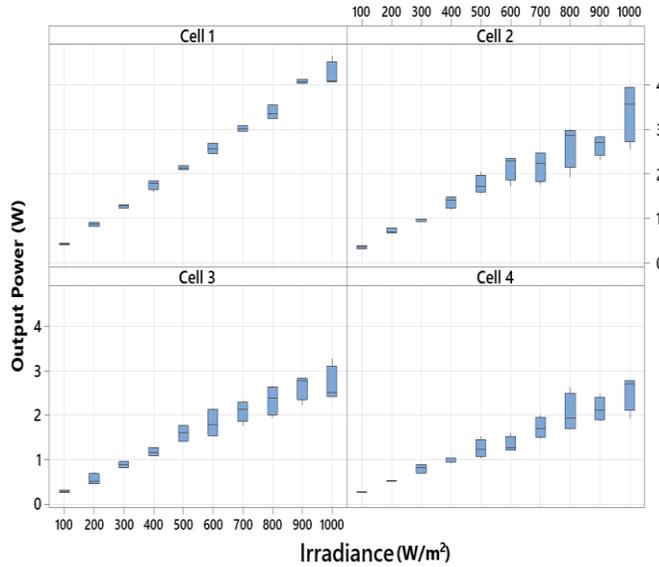
For sample #1, affected by minor cracks, the cell generated more output power, with an average power output of 2.36 W. Cells #2 and #3 show similar levels of cracking (as demonstrated by the dark areas in the EL image); so, their output averaged power at 1 Sun irradiance equals 1.81 W and 1.62, respectively. Finally, the maximum drop in the averaged power was observed for the last solar cell sample #4, which exhibited the most severe cracking and showed an output power of only 1.32 W.

Fig. 14. (a) Output power of the cells under illumination from 100 to 1000  $W/m^2$ , and cell temperature is 25 degrees, (b) Boxplot of the output power vs irradiance.

This data is supportive that as the crack size increases in solar cells, PID testing has a greater affect the output power performance. Furthermore, if we consider Fig. 14(b), the measured power has a more pronounced distribution away from the mean as the irradiance level increases. For example, the distribution of the measured output power at 1000  $W/m^2$  is  $\pm 15\%$  from the actual median value, while it is only equal to  $\pm 2\%$  at 100  $W/m^2$ .

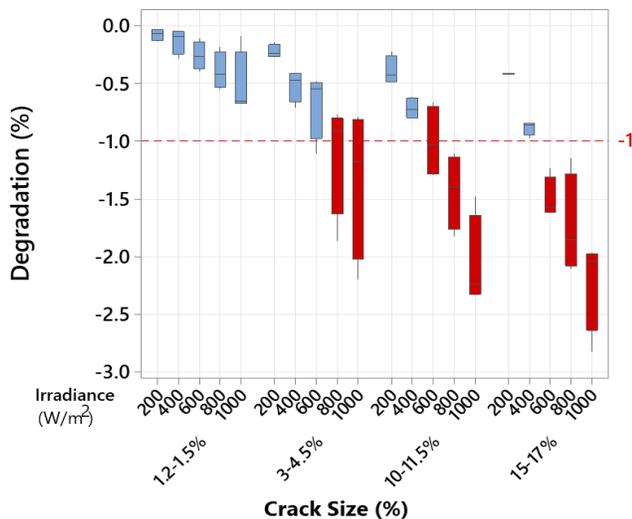
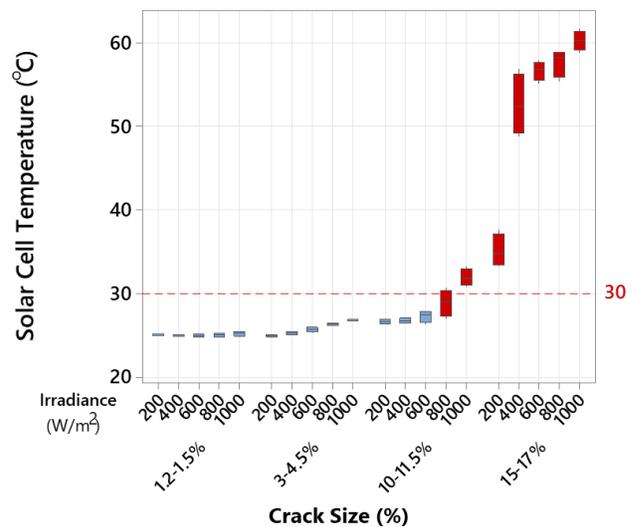
To consolidate the results, we have determined the crack size of each tested solar cell using the EL and LBIC images and assigned them into four categories, 1.2-1.5%, 3-4.5%, 10-11.5%, and 15-17%. The degradation rate for each category has been calculated by dividing the measured power by the theoretical power and the results are presented in Fig. 16(a). According to the largest study to date on PV degradation, [19], the median degradation is  $-0.5\%/year$  for a PV system, while for a standalone solar cell sample is  $-1.0\%$ . Accordingly, in Fig. 16(a), we have labelled in "red" all calculated degradation rates that were observed below  $-1.0\%$ . As a result, we found no significant degradation in the cell with 1.2-1.5% crack size, while for all other considered crack sizes, a significant degradation is observed.

Similarly, we observed the thermal performance (cells temperature) under varying solar irradiance (see Fig. 16(b)). The results show that for the crack sizes from 1.2-11.5%, it is unlikely the cell develops a hotspot (nearly all measurements are below the standard baseline of  $30^\circ C$ , IEC61215/61646). In contrast, if the crack size is in the range between 15-17%, a hotspot is expected to develop and has an increase in the cell's temperature to approximately  $60^\circ C$ .

Fig. 16. Irradiance spectrum of the crack size vs. (a) Degradation, (b) Temperature.
